Your Property Inspection Report

131 Bridlewood cm sw, Calgary, Ab

Date of Inspection: 1/23/2016 Time: 2pm
Age of Home: 1998
Weather: 8degrees
Two storey walkout developed basement 80% finished.
Facing North

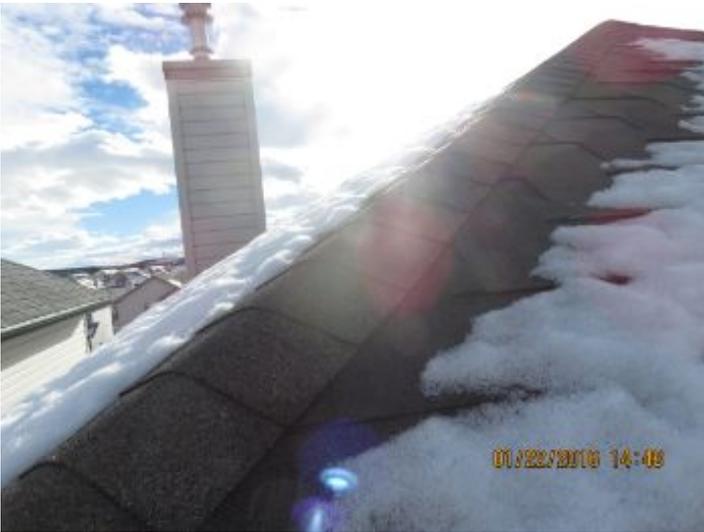
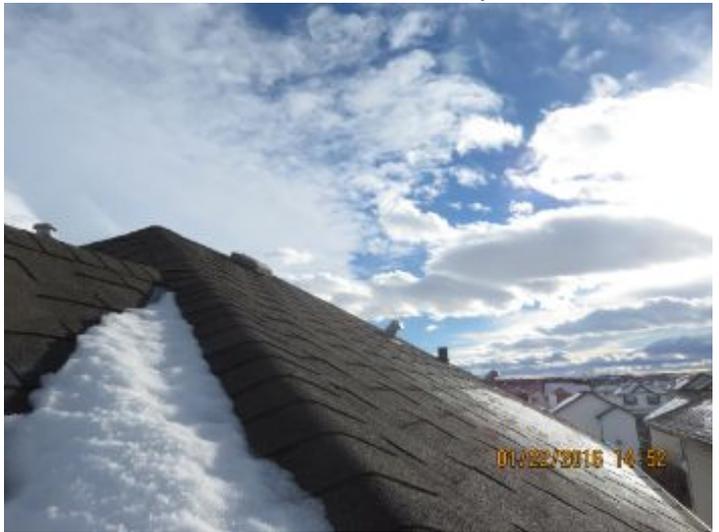
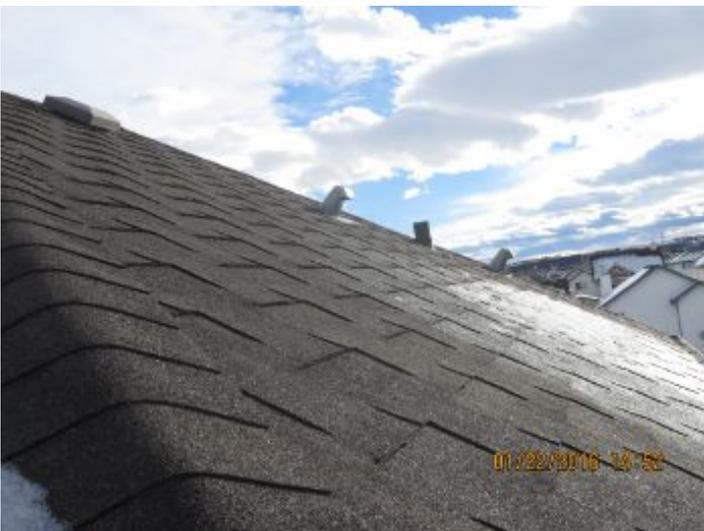
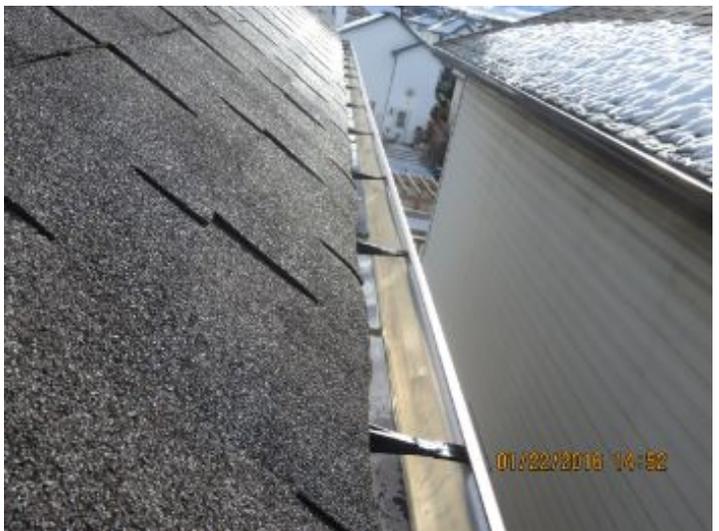
Snow cover not a full inspection

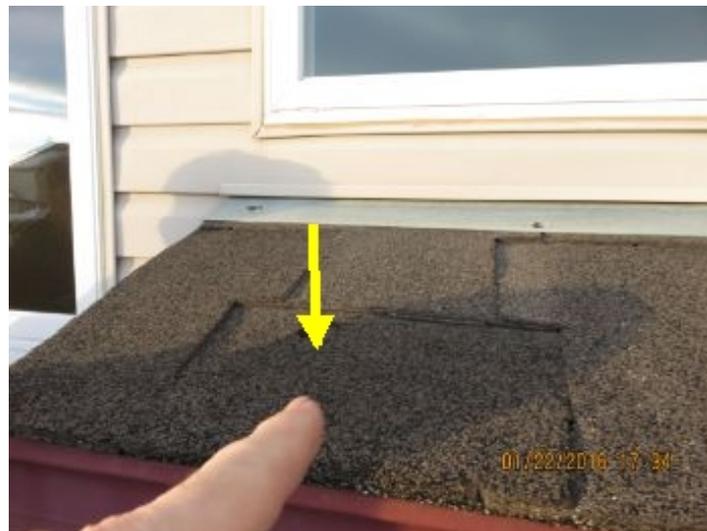
Shingle repairs over the fireplace roof

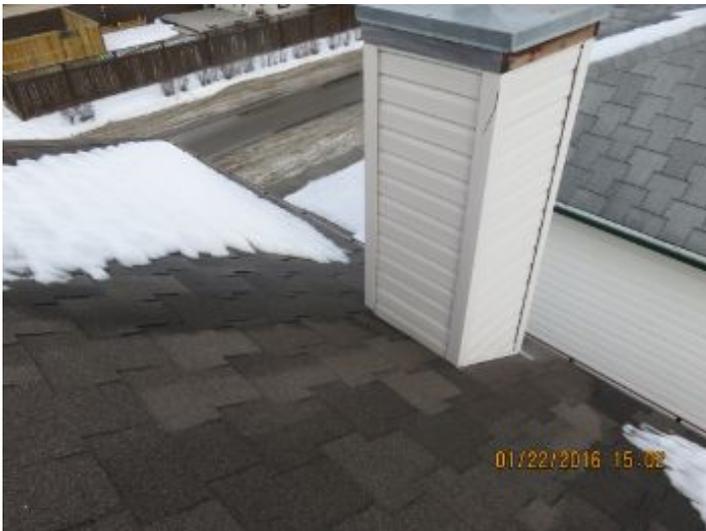
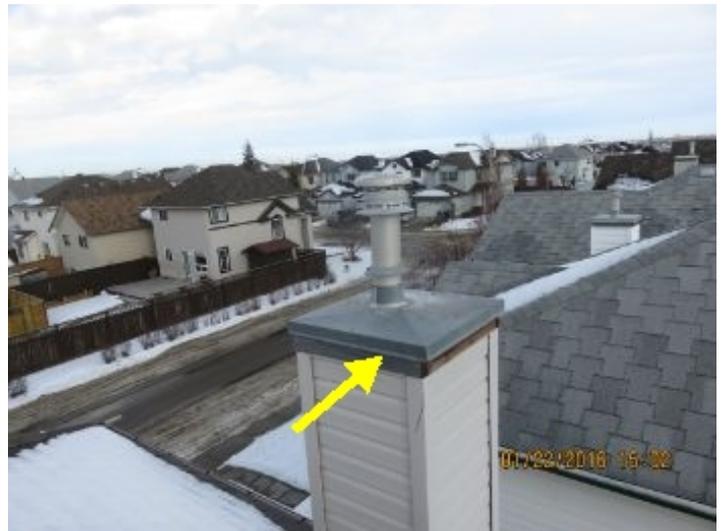
No major system safety or function concerns noted at time of inspection. Wood trim needs paint

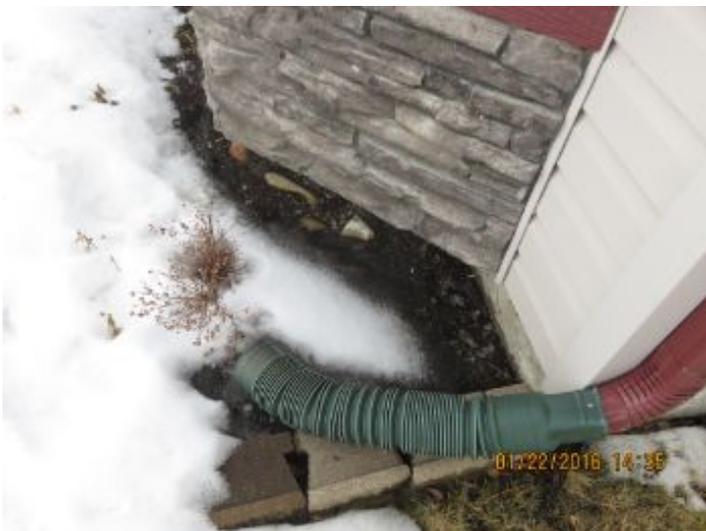
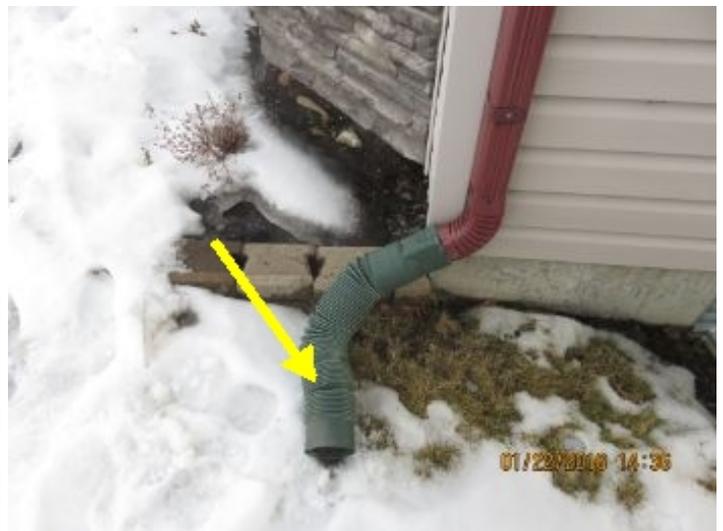
Recommend discharging the water away from the home to avoid excessive discharge during heavy down pours in the summer conditions.

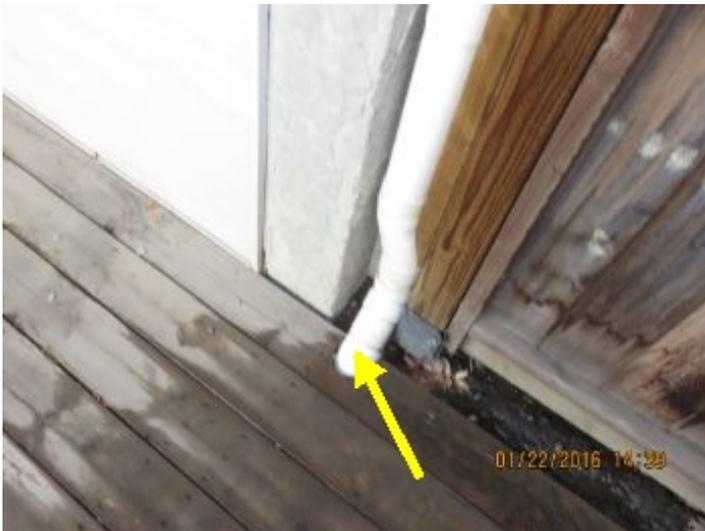
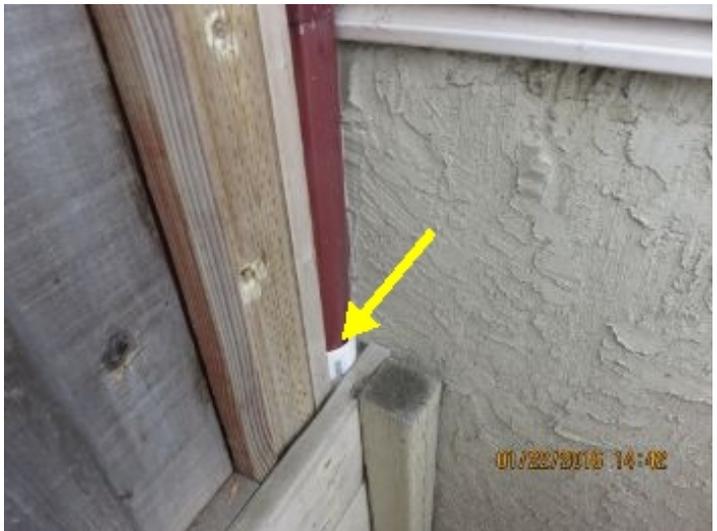
Down spout connected to underground pipe. Recommend reconnecting a down spout during winter conditions. water freezes and can crawl up the down spout preventing any drainage and then fills the gutter and will eventually damage and loosen because of the weight of the water. Extend the downspout at least 4ft away from the foundation

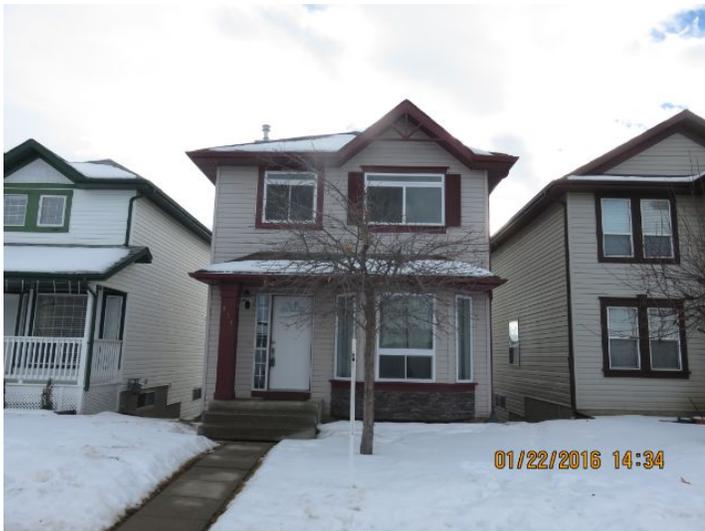
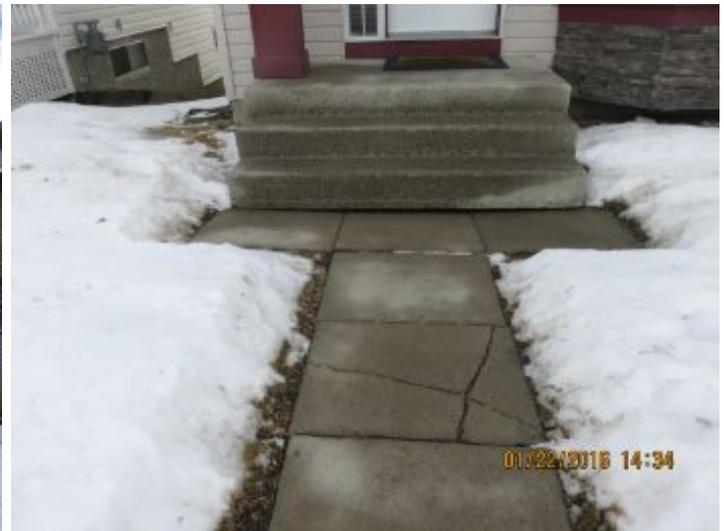
Sidewalk blocks can have a tendency to lift during winter conditions and become a tripping hazard. Some of these blocks need readjusting and some need replacing.

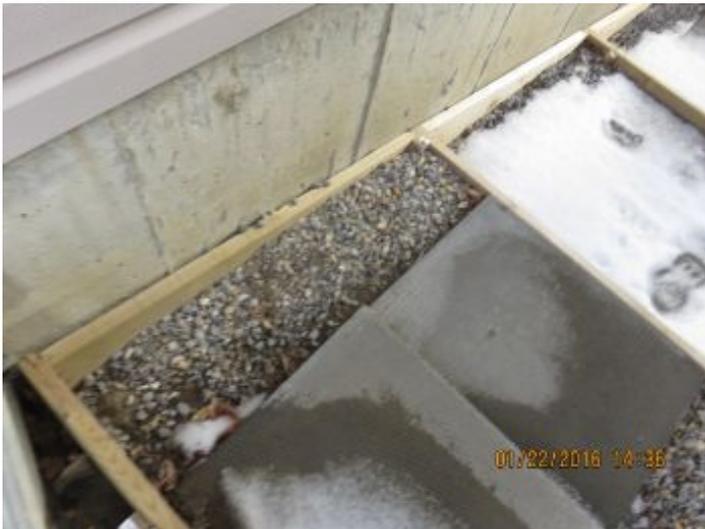
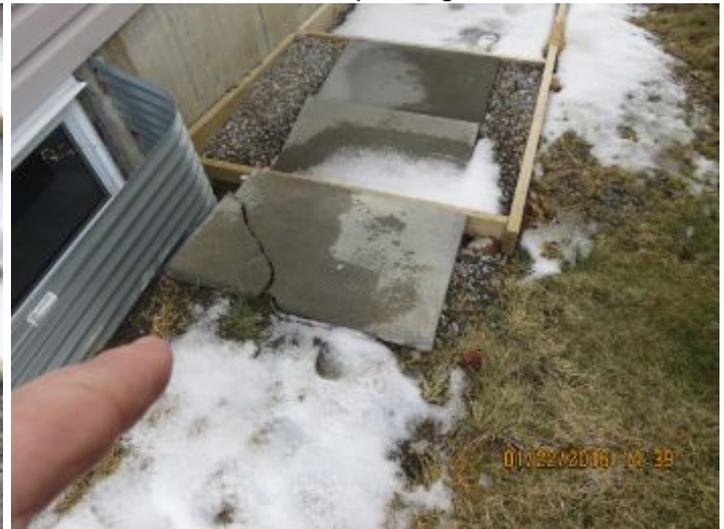
Sidewalk blocks can have a tendency to lift during winter conditions and become a tripping hazard. Some of these blocks need readjusting.

Trip hazard

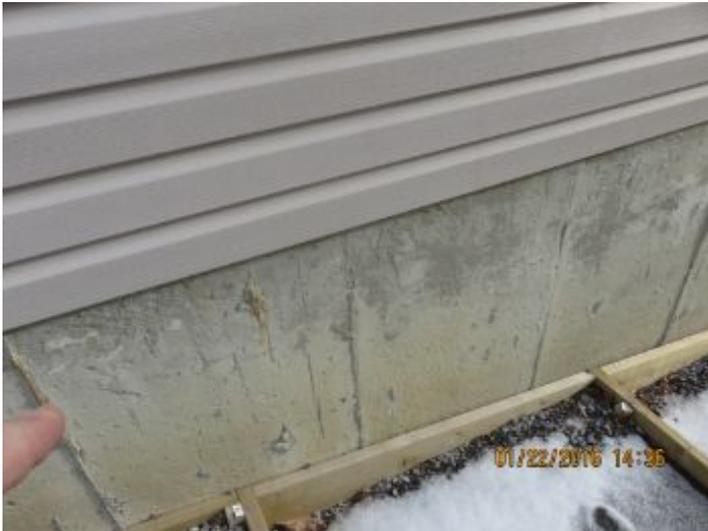
Parging was missing on this wall. This parging finish is more cosmetic not a concern.

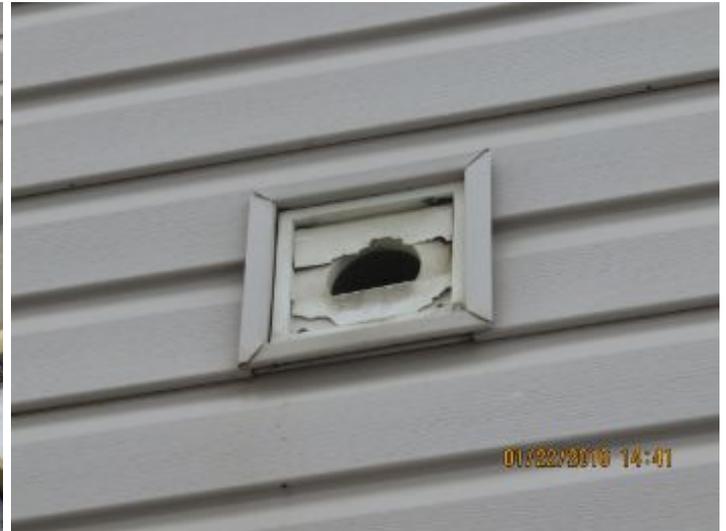
Main floor exhaust cover is damaged. Great for bird nesting

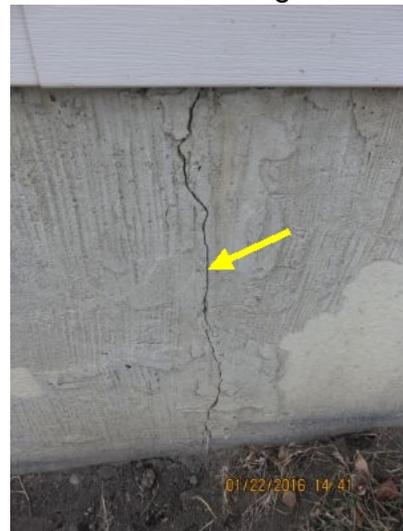
This crack is typical even at construction stages. This is located on the mechanical wall side. Monitor during spring for any possible water in the mechanical room.

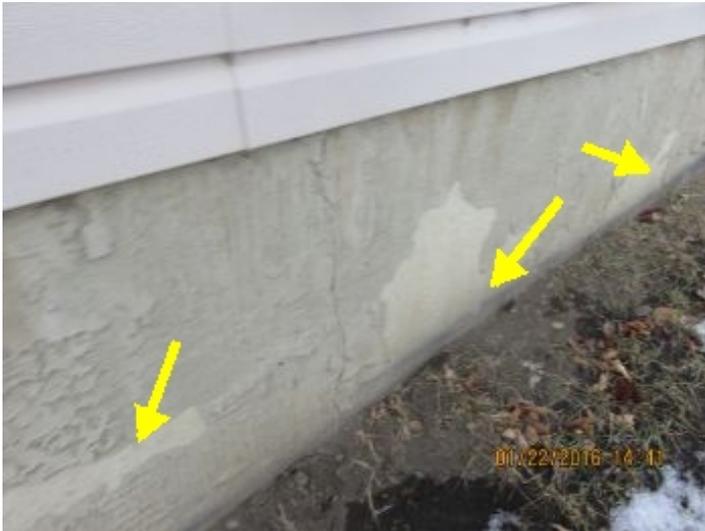
Parging is patchy

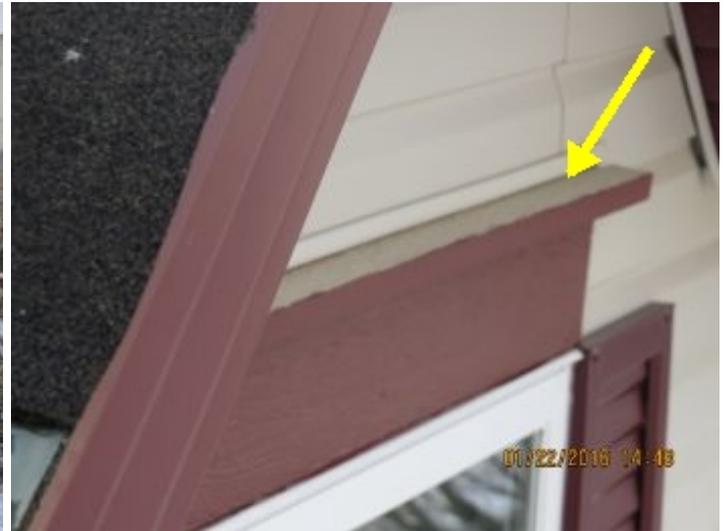
New code recommends a drip cap above the wood trim finish

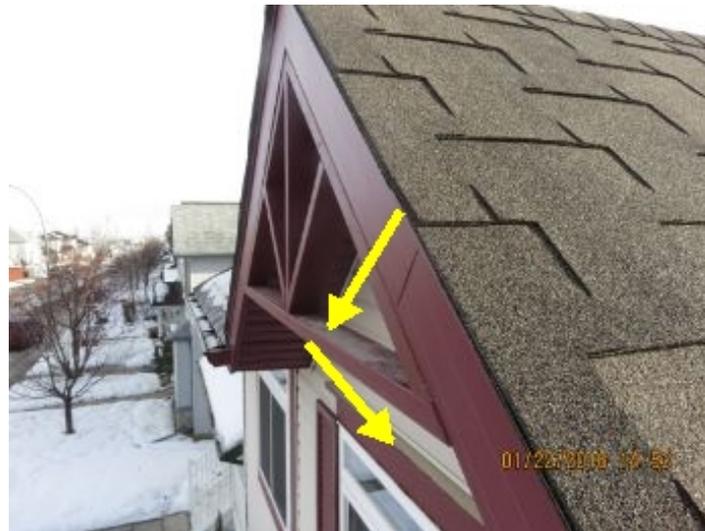
All wood trim needs painting to seal and avoid wood rot

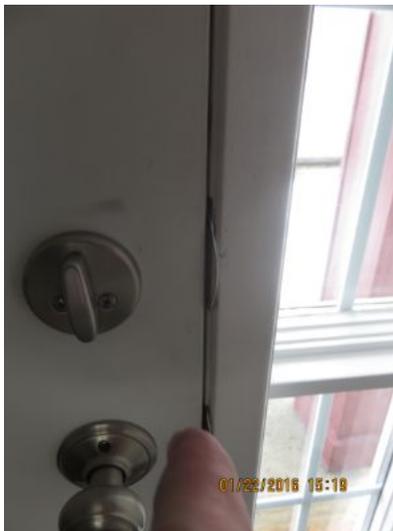
Front door rubs. Minor adjusting

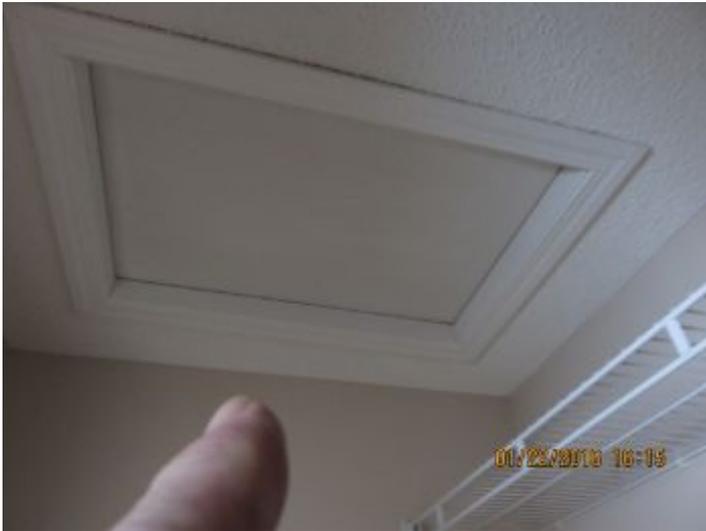
No insulation over attic hatch; recommend installation, then apply a weather stripping to minimize heat loss.

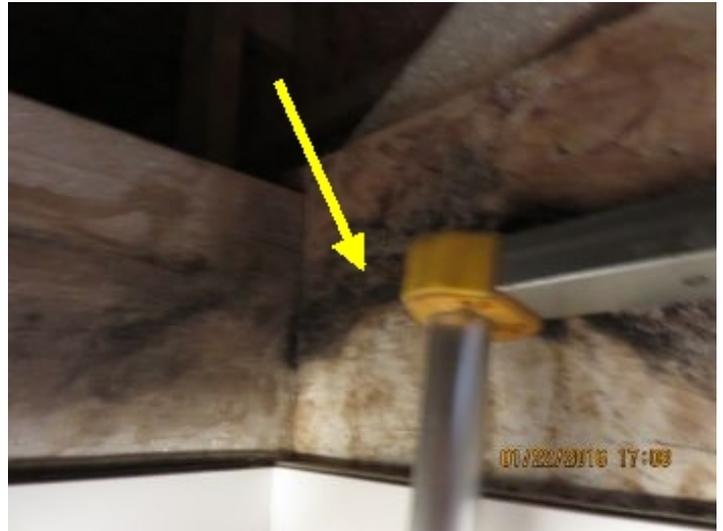
Air leak and no insulation is damaging the wood

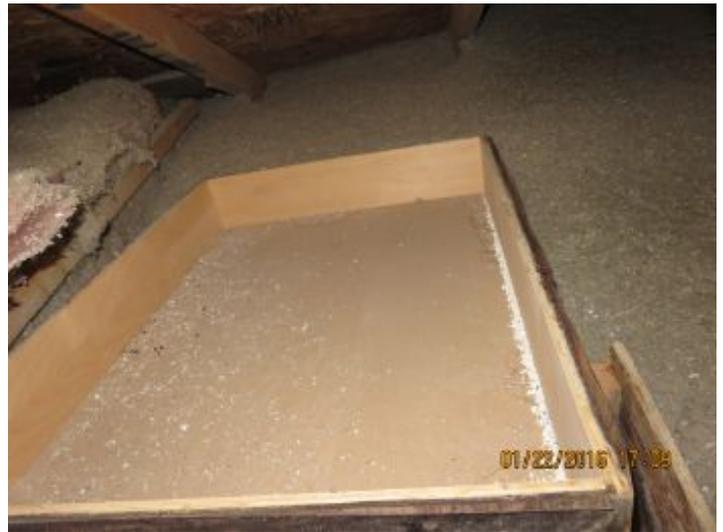
No insulation over attic hatch; recommend installation, then apply a weather stripping to minimize heat loss.

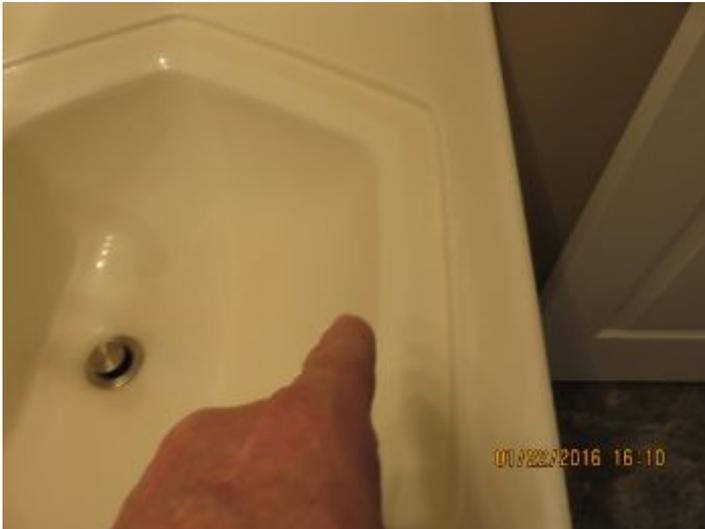
Sink has no overflow drain; use with caution.

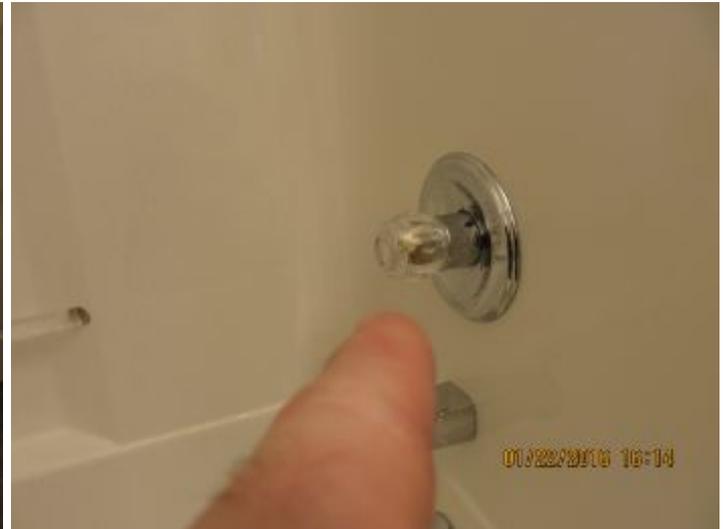
Tub water temperature was not warm compared to the bath sink. The tub adjustment setting is located behind the tap cover. Recommend a plumber to repair.

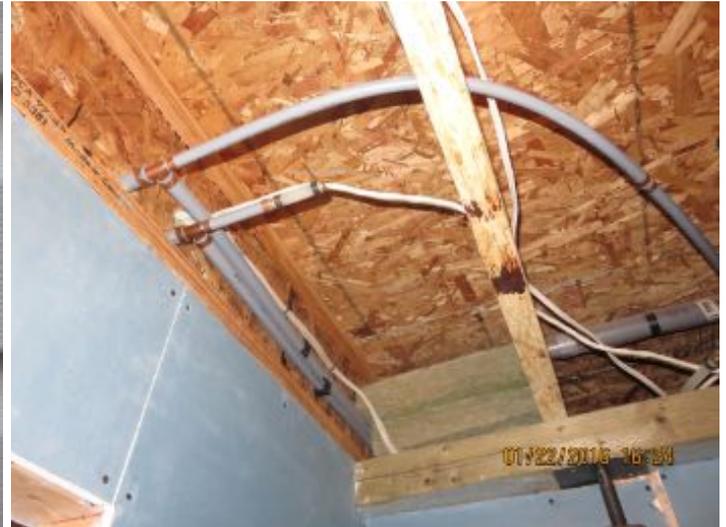
Polybutylene with plastic fittings visible. These can be less dependable than other types of supply piping systems. Recommend reviewing the seller's property disclosure statement for comments on Polybutylene plumbing supply lines in this house.

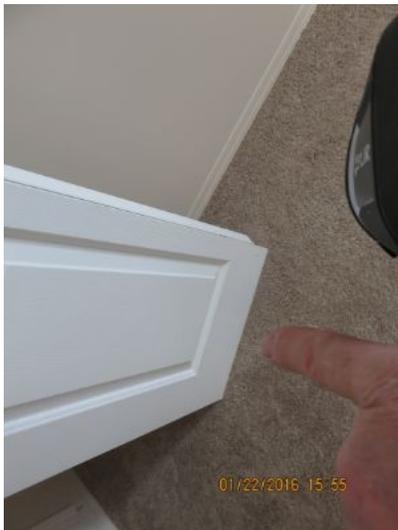
Bifold door was damaged in the north bedroom.

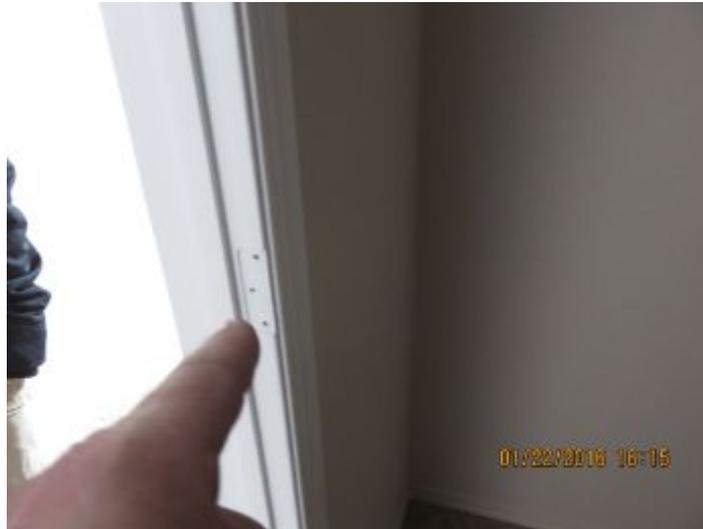
Master closet door missing
