Your Property Inspection Report

131 Bridlewood cm sw, Calgary, Ab

Date of Inspection: 1/23/2016 Time: 2pm
Age of Home: 1998
Weather: 8degrees
Two storey walkout developed basement 80% finished.
Facing North

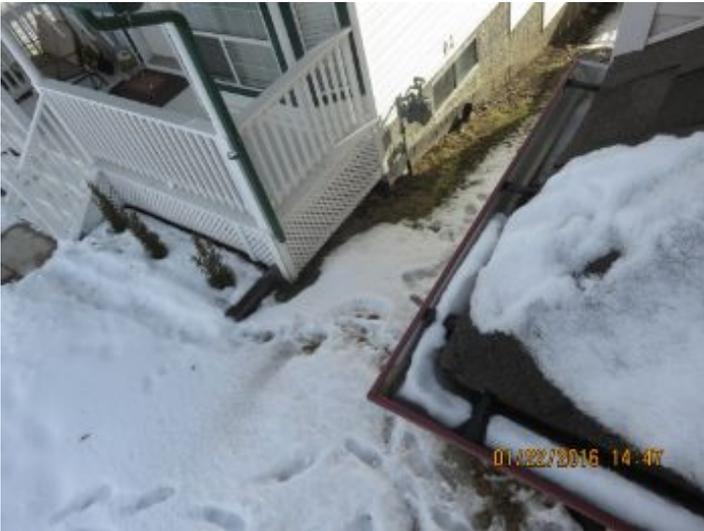
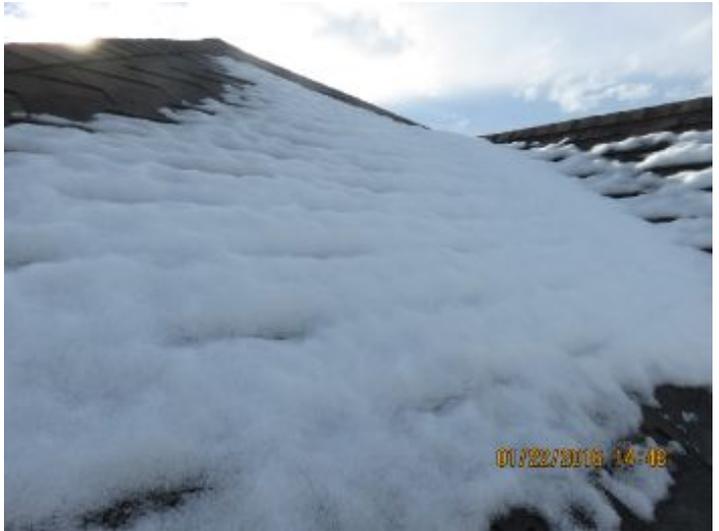
Snow cover not a full inspection

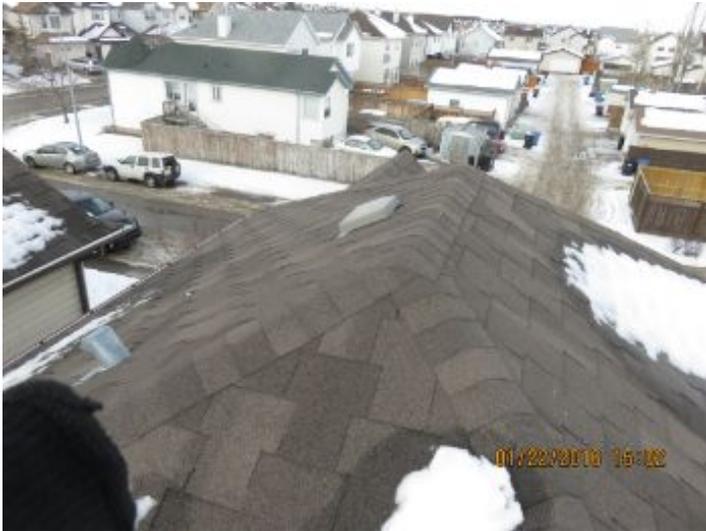
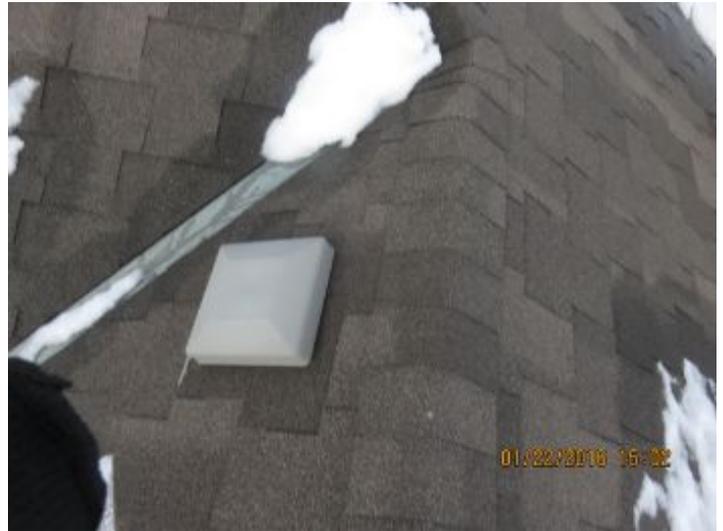
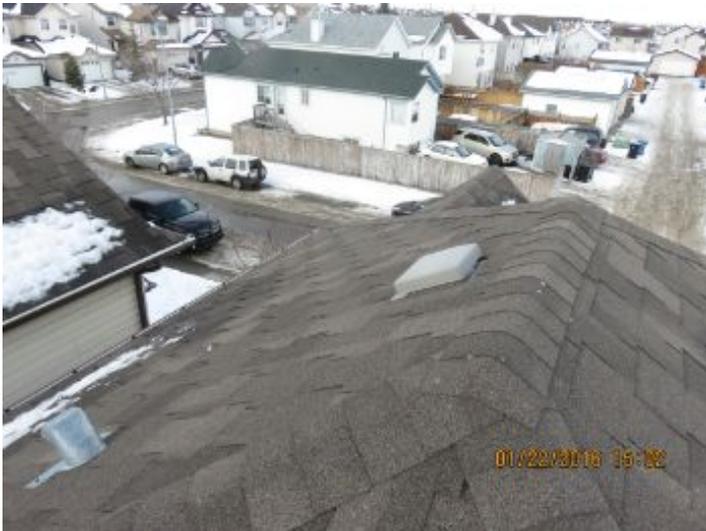
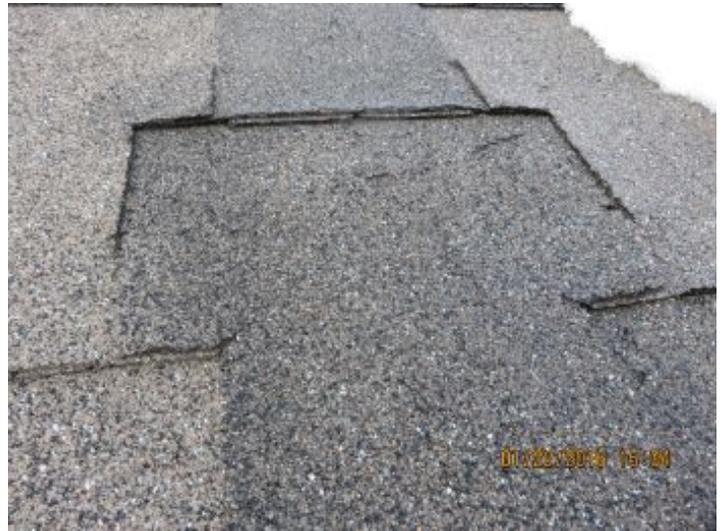
Interlocking shingles

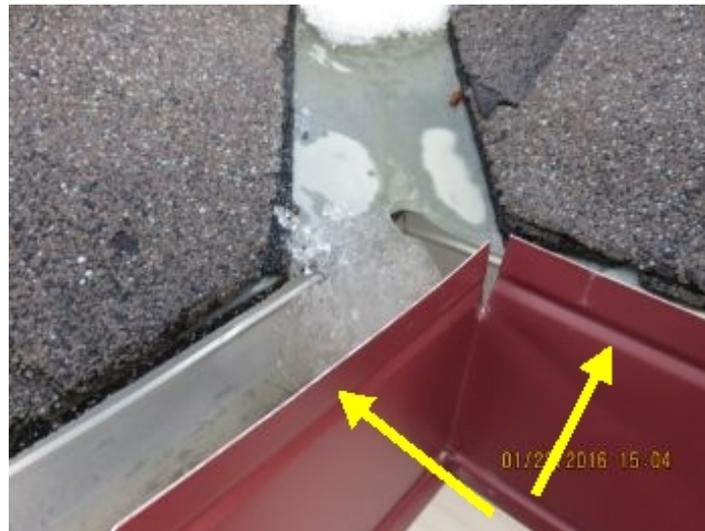
Down spout connected to underground pipe. Recommend reconnecting a down spout during winter conditions. water freezes and can crawl up the down spout preventing any drainage and then fills the gutter and will eventually damage and loosen because of the weight of the water. Extend the downspout at least 4ft away from the foundation

Underground connection noted

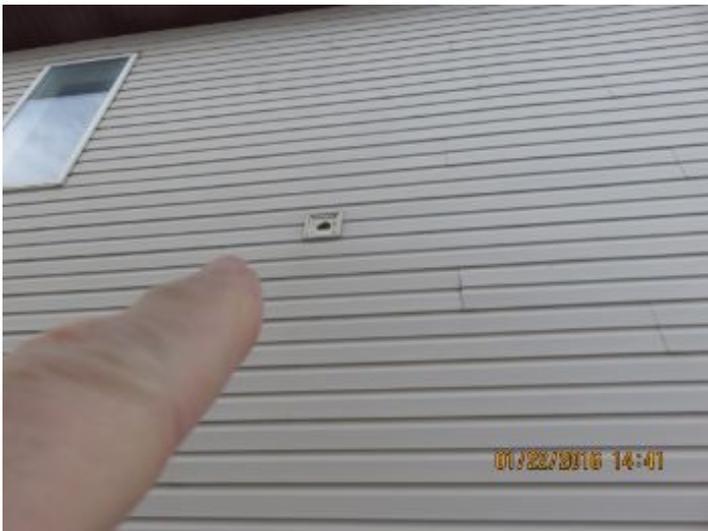
Main floor exhaust cover is damaged. Great for bird nesting

Vent repair

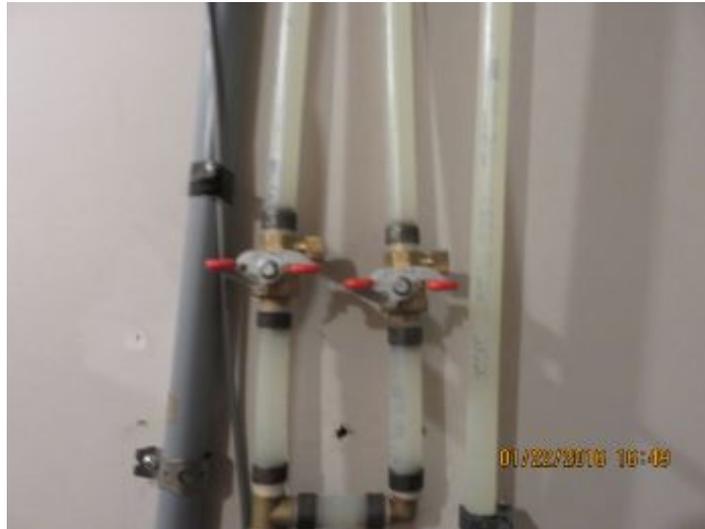
Exterior water shut offs. In the off position.

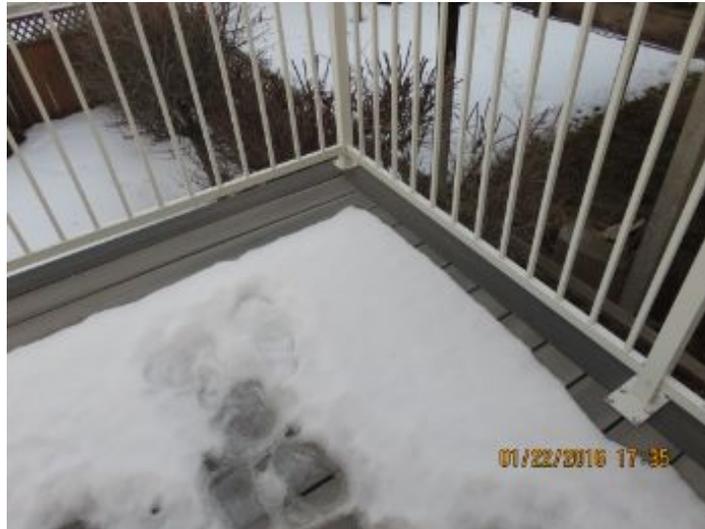
To protect your deck from snow load damage or collapse, we recommend that the the snow be continually cleared. Note that the snow load and snow load capacity of a deck is beyond the scope of a home inspection.

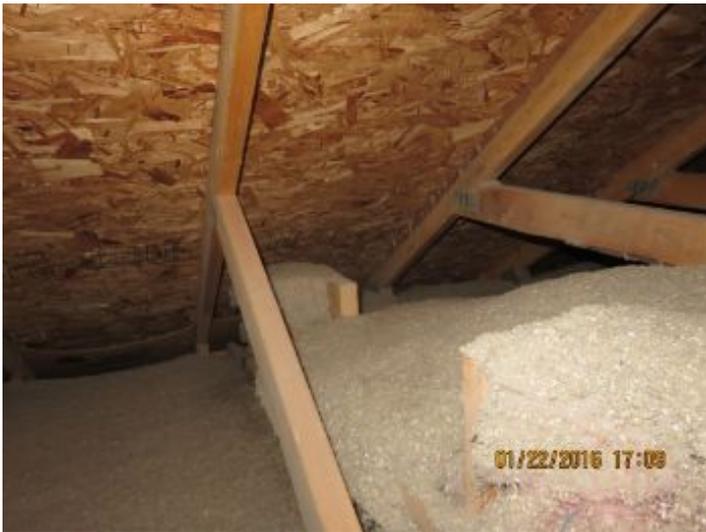
Air leak and no insulation is damaging the wood

No insulation over attic hatch; recommend installation, then apply a weather stripping to minimize heat loss.

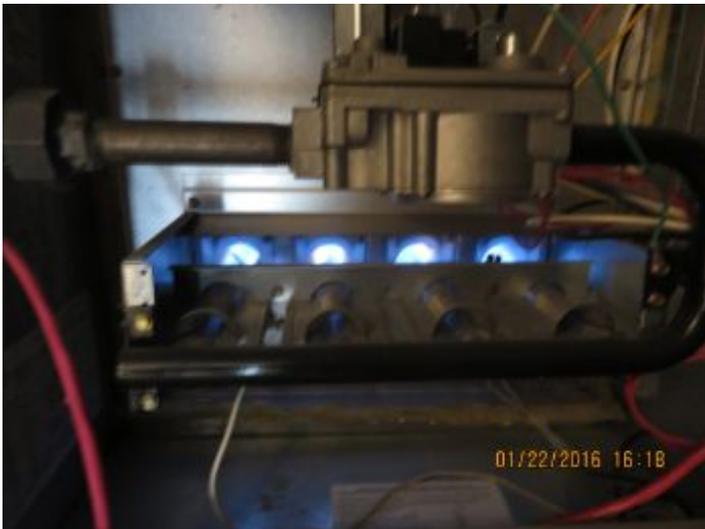
Low and Mid to High efficient furnaces can fail at any time. For peace of mind. I recommend your gas supplier inspect your furnace for possible Carbon monoxide and proper function. This is a free service and they are not their to sell you anything. They are their to test and educate you .

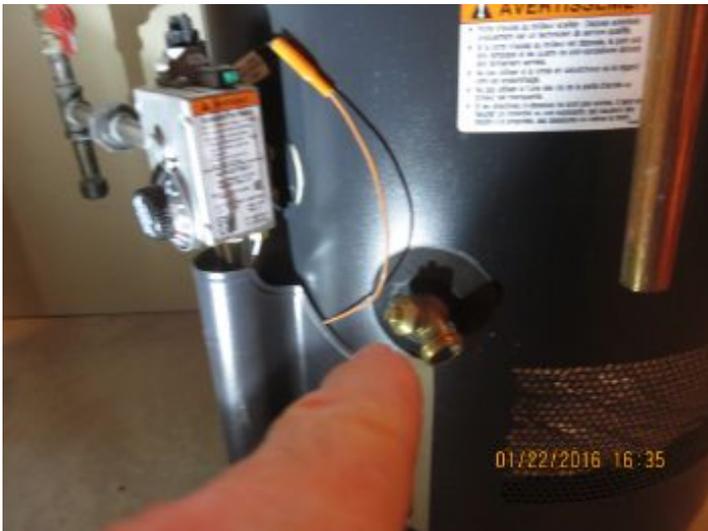
Recommend draining the hot water tanks at least once a year this will prolong the life of your tank. Normal life cycle of an average hot water tank is around 12 to 15 years.

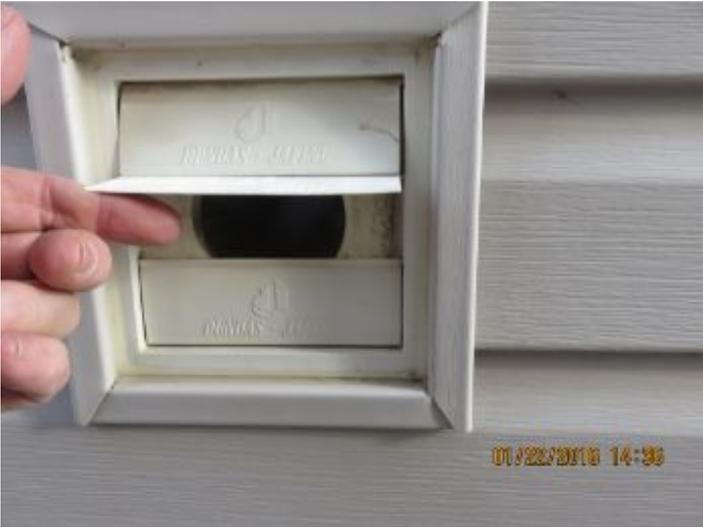
Always monitor the dryer vent on the exterior especially in the winter months. Lint build up may occur and cause the vent flaps to stay open which in turn will plug up the pipe and cause the dryer to over heat

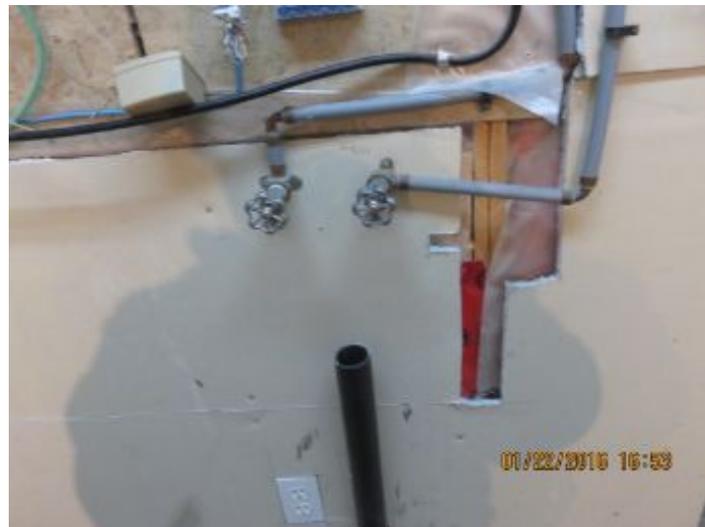
Polybutylene with plastic fittings visible. These can be less dependable than other types of supply piping systems. Recommend reviewing the seller's property disclosure statement for comments on Polybutylene plumbing supply lines in this house.

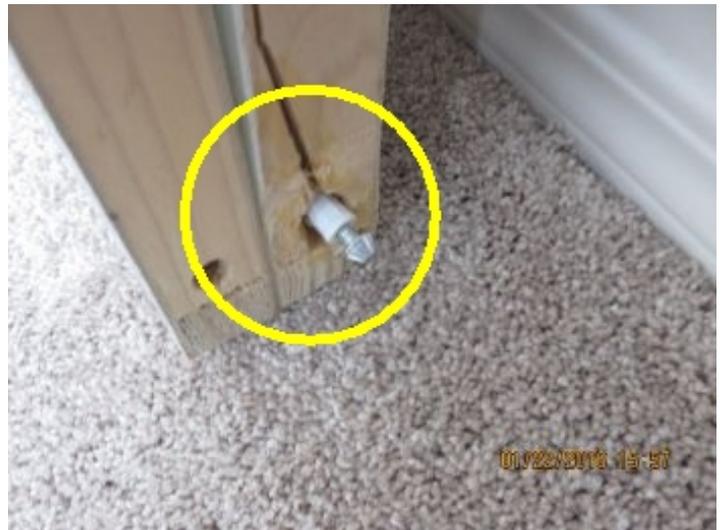
Bifold door was damaged in the north bedroom.
